# ATLAS Safety Bulletins

## Near-miss Case Studies

## 1. Industrial Chimney Inspection

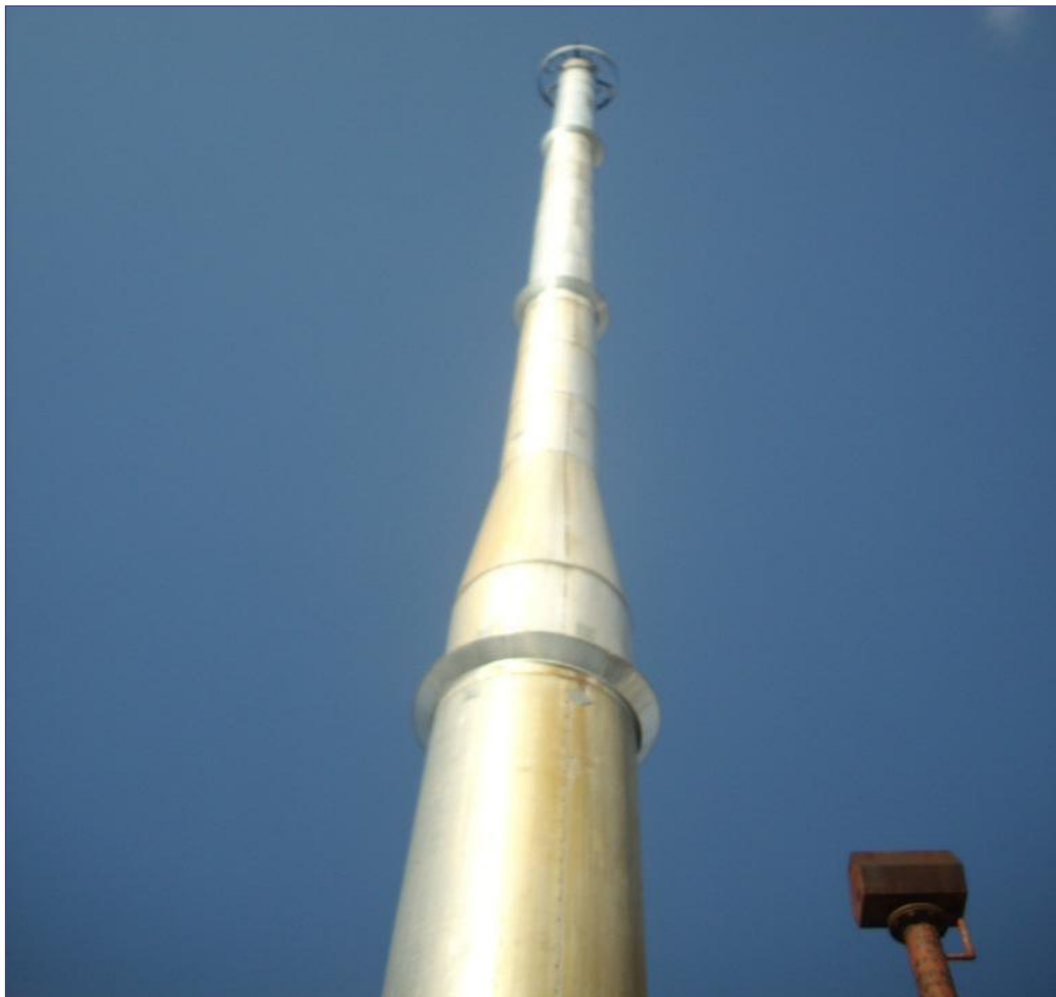
The 36.0m tall chimney prior to the inspection - fully clad and insulated

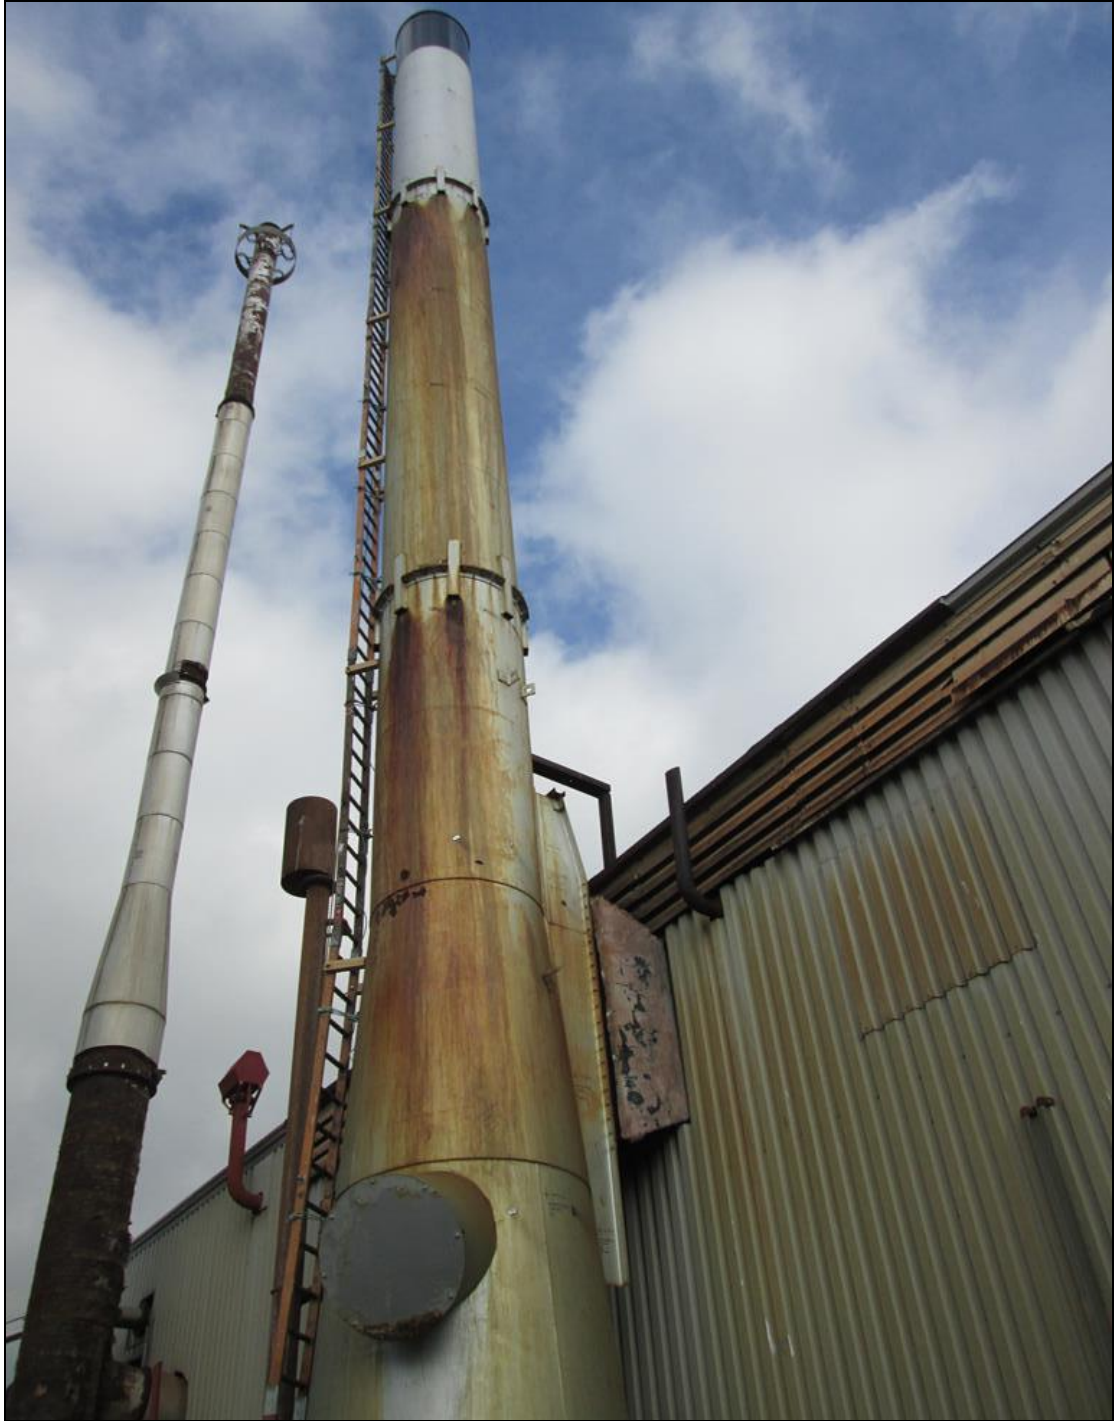
The chimney in question can be seen in the background with sections of the insulation and cladding removed.

The chimney nearest has been inspected using powered access and deemed to be structurally sound. Steeplejack ladders together with fall arrest systems have been installed to facilitate the undertaking of remedial repairs and painting work to this particular chimney.

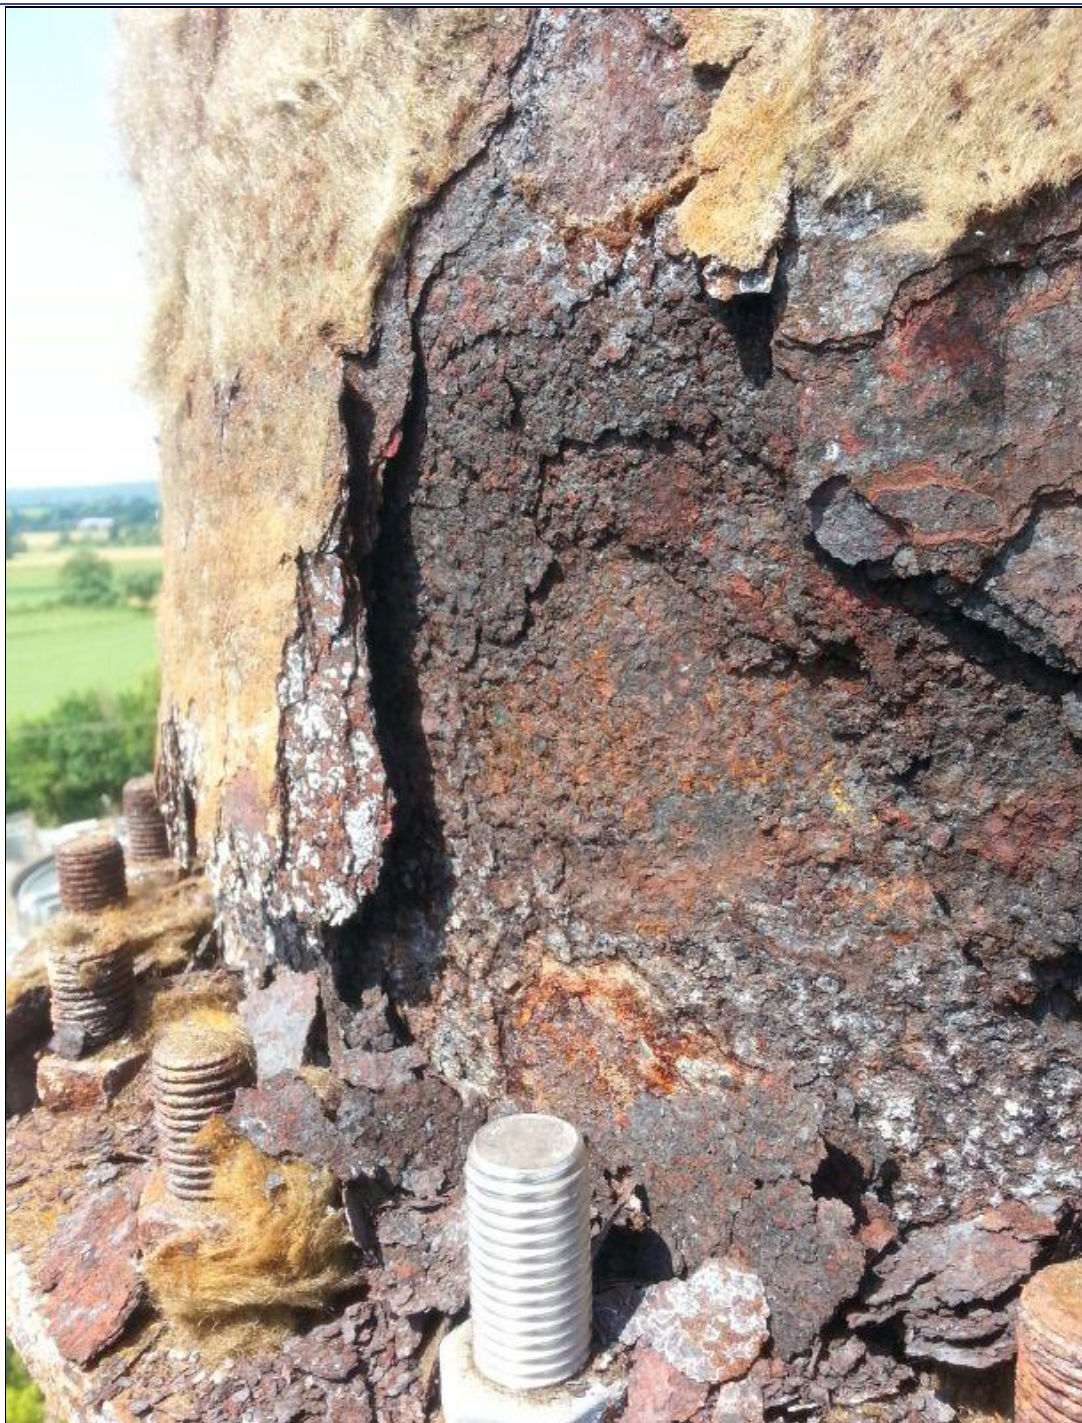
Following the removal of the insulation and cladding, extensive loss of the structural steel plate thickness was revealed immediately above the top two bolted flange connections. This loss of steel thickness had completely compromised the structural stability of the chimney. Mobile cranes were brought to site and the top two chimney sections were safely removed.

Advanced corrosion at the top flange – structural walls were found to be paper thin.

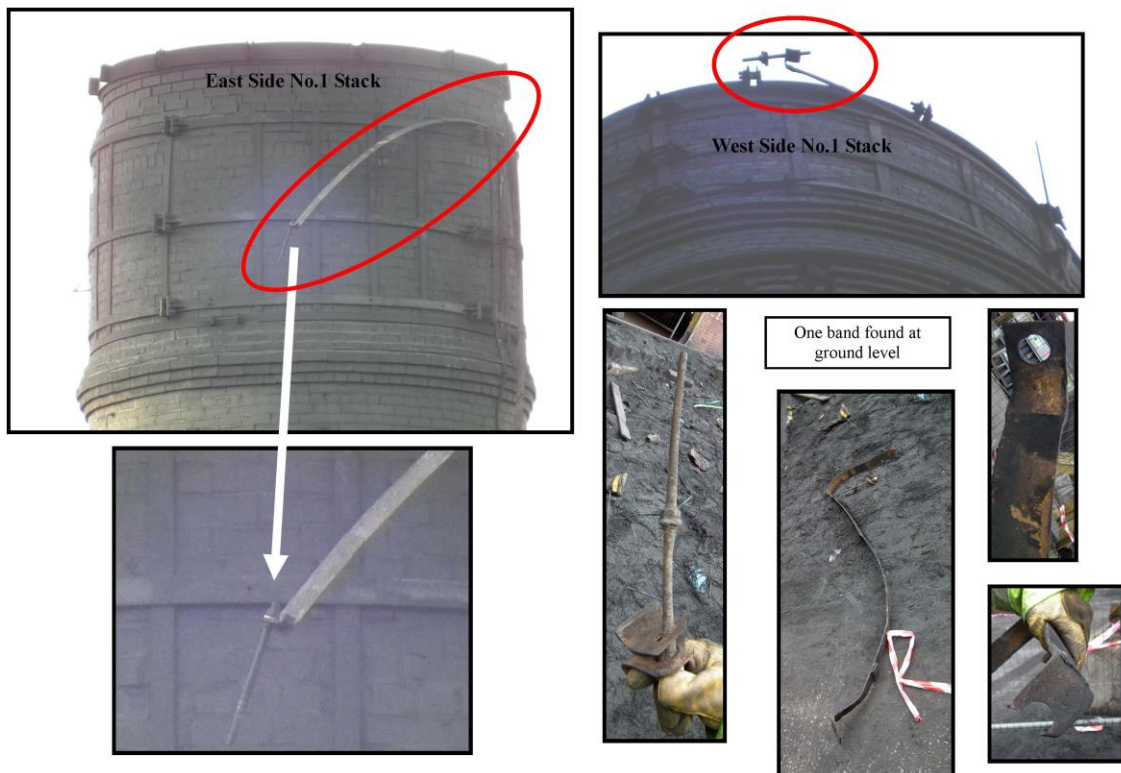
An ATLAS member company was recently contacted by a client reporting that a steel band had broken free from the summit of a brick chimney. Unfortunately the dangerous state of the structure, combined with poor weather conditions, prevented the steel band from being removed in a controlled manner and sections of the band fell to the ground from a height of 75m.

The failed steel band

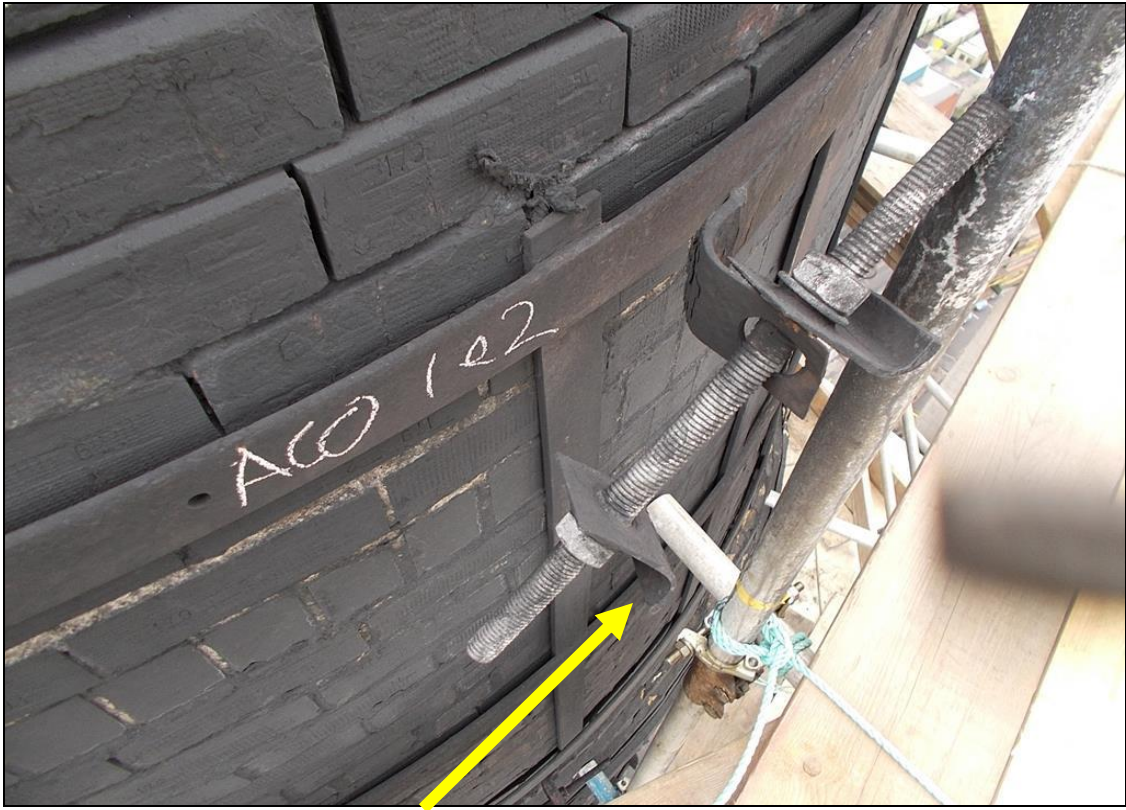
Location where the band had failed

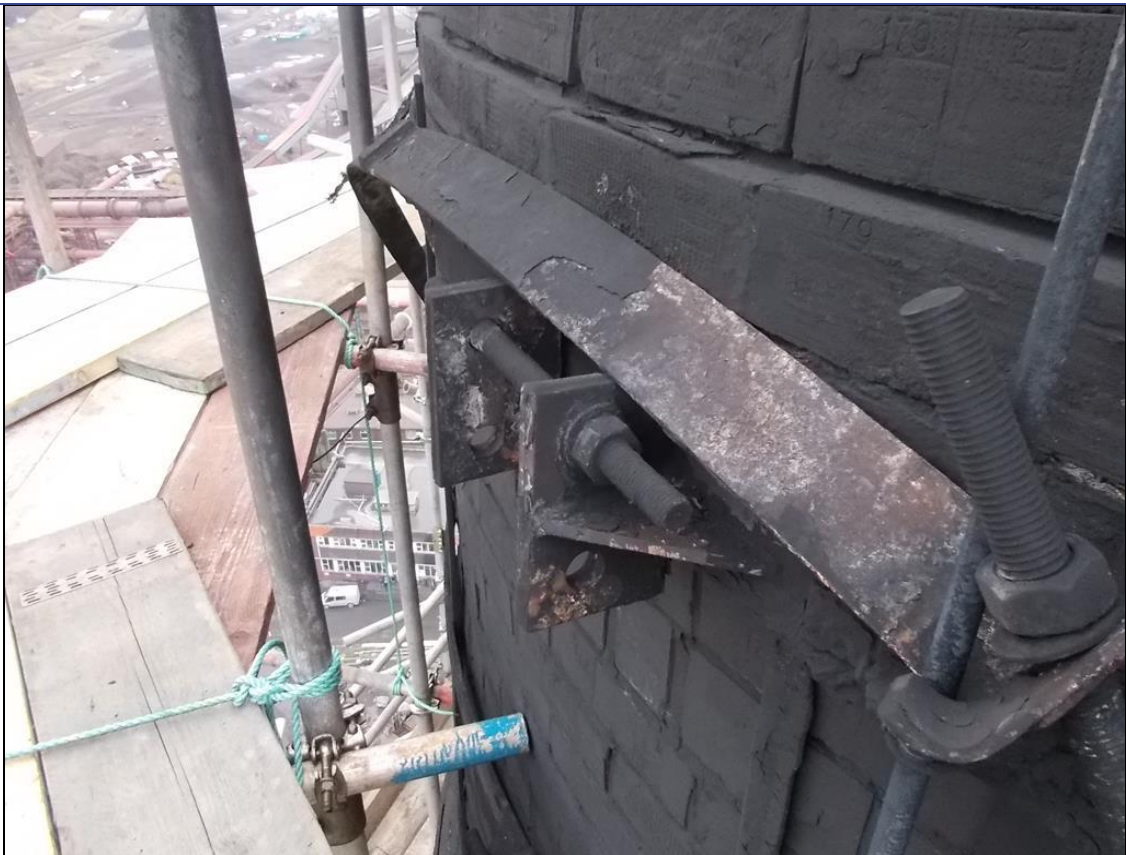
Sections of the band lodged behind a lightning conductor air terminal

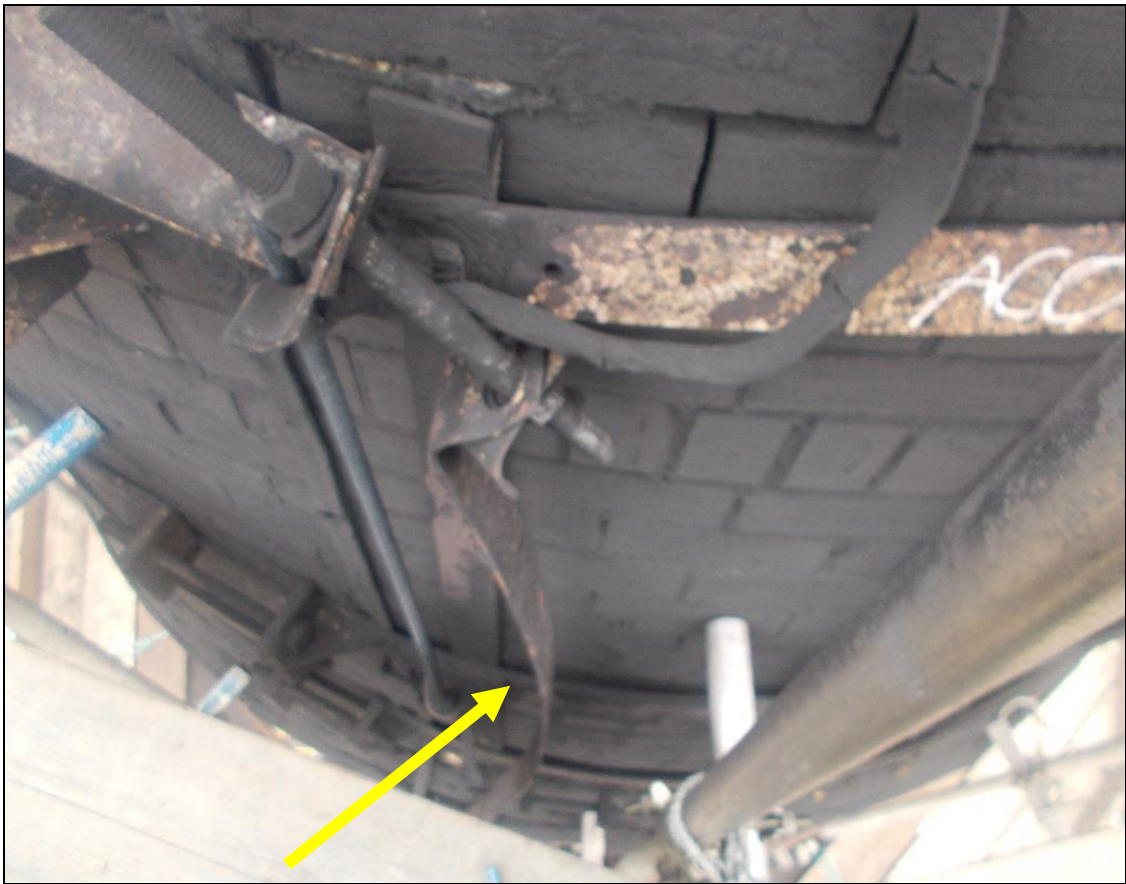
Section of the band left hanging

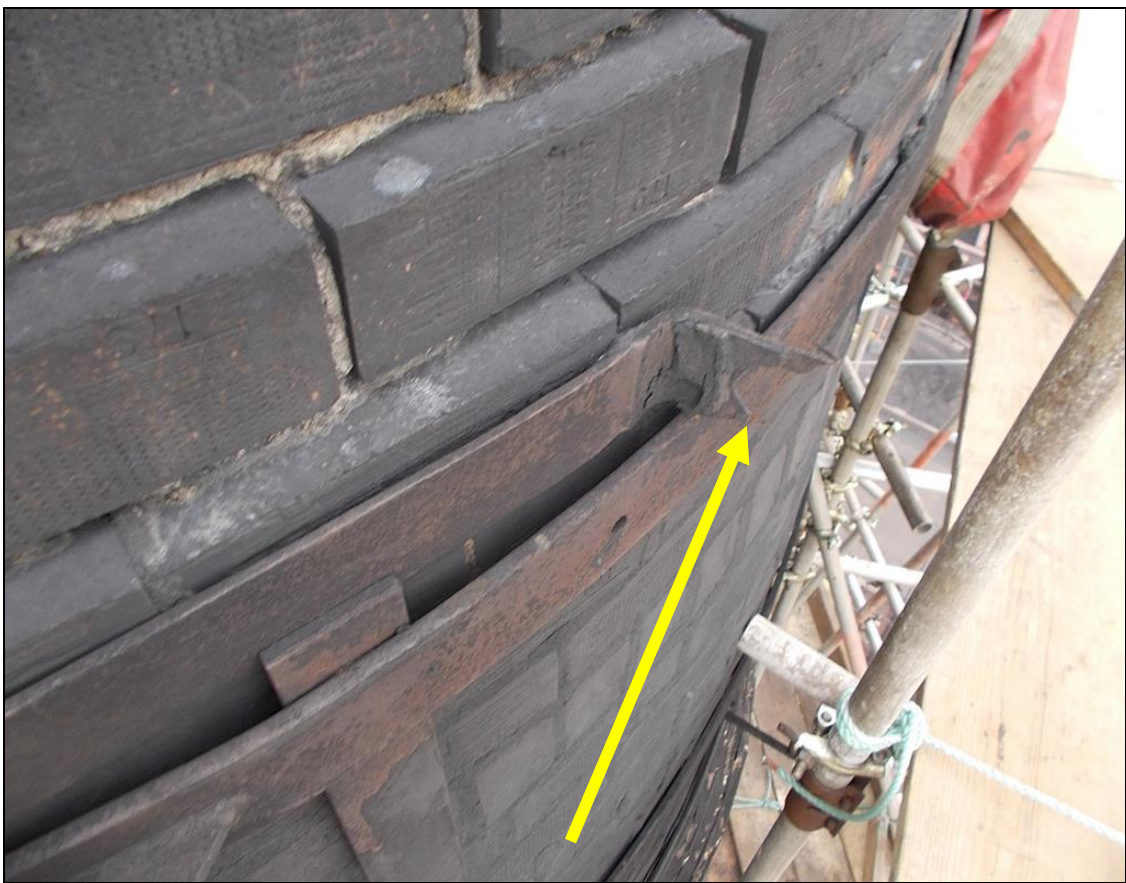
Section of the failed band stuck behind other steel work

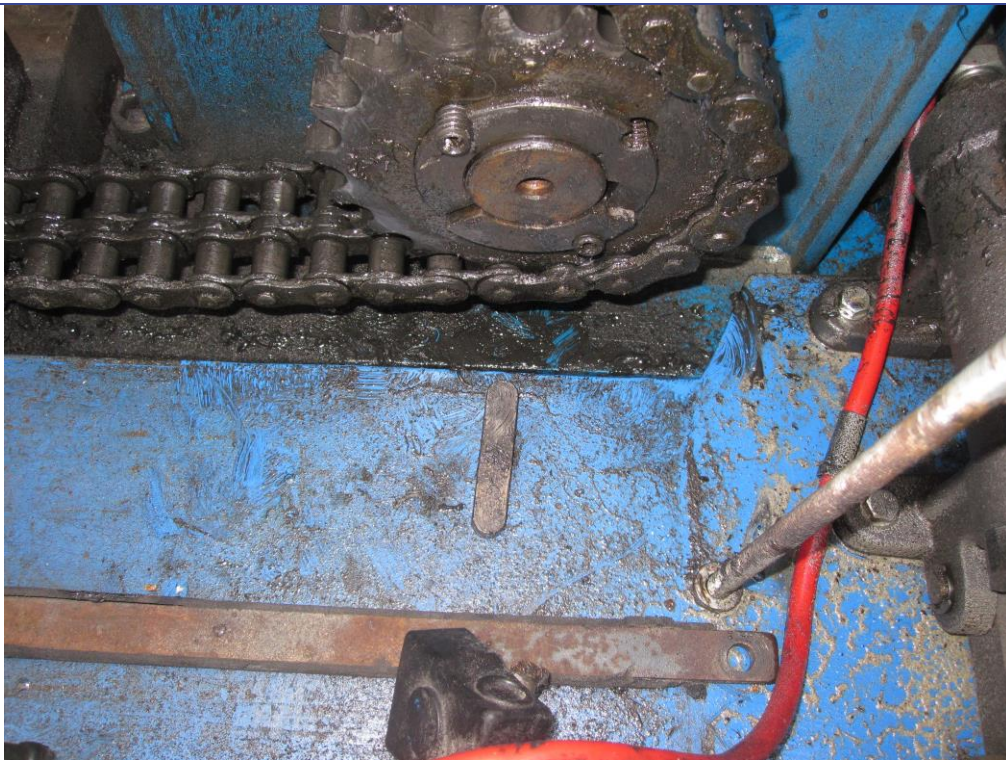
The rear cog detached from the spindle and the woodruff key worked loose. A mechanical failure of the Taper Lock prevented the spindle staying engaged with the cog.

The failure of the Taper Lock caused the uncontrolled descent. It has highlighted the need for more checks to the arrangements on the winches that could cause a failure. The

**If any member companies are operating Thompson 21/60 diesel winches, we recommend that you have them checked with the manufacturer for the Taper Lock arrangement and any other item that could cause failure.**
