THE MALAGO

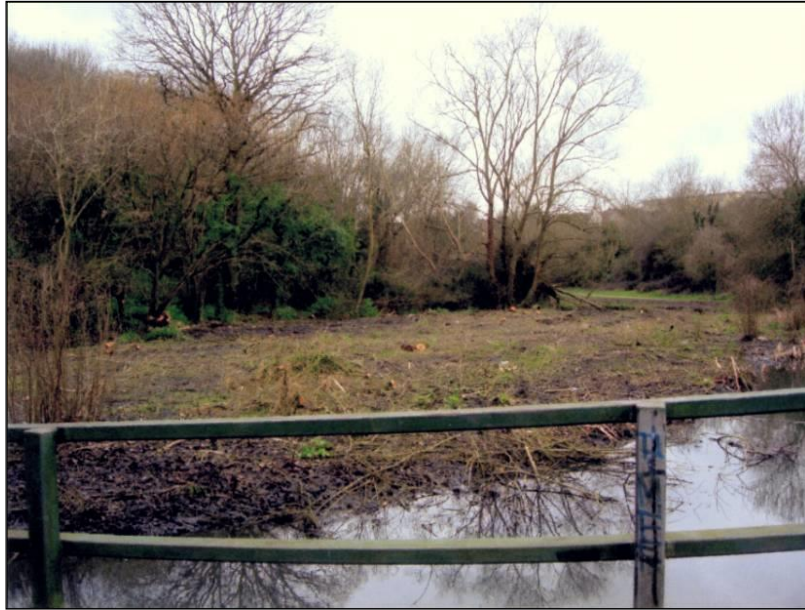
In anticipation of de-silting of the pond, BCC cleared the developing Crack Willow scrub from the area during the winter of 2009-2010; however, the de-silting did not occur and instead the Willow was left to re-grow into the coppice woodland that we see today.

2010 – the silted-up pond cleared of scrub Willows

The 2007 annual 'Amphibious Garbage Raid' revealed less rubbish in the stream than in some previous years; notably, for the first time since its creation in 1976, the pond was not identified as a separate entity that year. It had become effectively fully silted despite an anticipation voiced some eight years previously that BCC intended to clear the silt 'in the near future'. The intention was for BCC to liaise with the Urban Splash development company with regards to their 'Lake Shore' development at the former Wills factory in Crox Bottom. When Urban Splash got the contractors in to clear their lake, the council hoped to get them to come to Manor Woods Valley, thereby saving some of the cost of employing them separately. MVCG were contacted by consultants employed by the Council to look at options for doing the work. Due to the huge cost of moving the silt off-site, a major part of the study was to identify a suitable site or sites within the site on which to dump the silt.

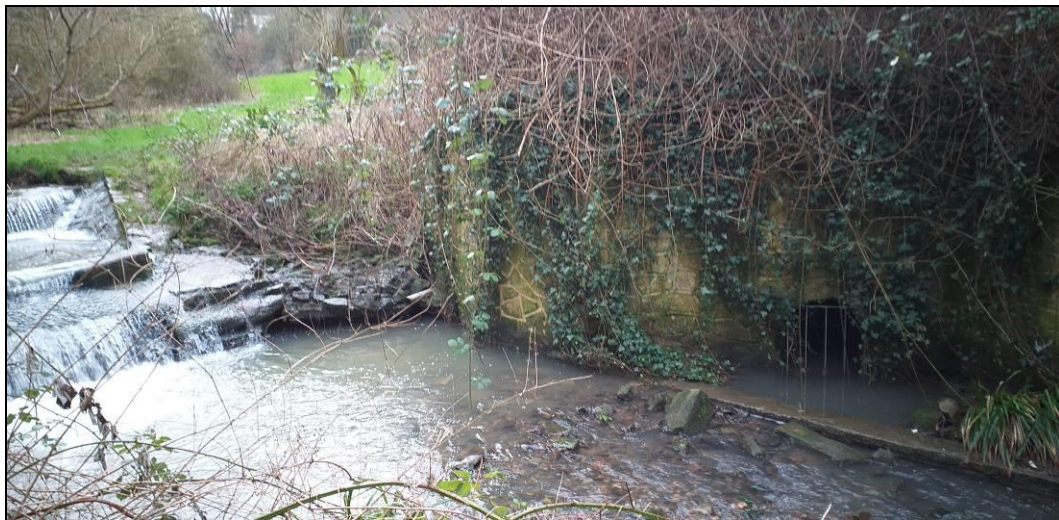
As a result of the work by Bristol University Students and increasing public awareness of inland water quality issues, in 2020 MWVG started to take a particular interest in the water quality of the Malago. It soon became clear that there are four Combined Sewage Outfalls (CSO's) upstream of Manor woods Valley, and one within it. The latter is situated immediately downstream of the Lower Stepping Stones.

The CSO on the Malago in Manor Woods Valley

CSO's discharge untreated sewage and waste-water when the sewerage system is overloaded during periods of intense rainfall. Without CSOs, sewage could back-up in to houses and gardens. As CSOs should only operate during periods of unusually intense rainfall. Foul water released from them is very dilute because of the large volumes of rainwater within the system. Flows are further diluted by the receiving watercourses that will also be swollen by the same heavy rain. CSOs are fitted with screens that help remove debris from the flow and minimise any environmental impact.
